# EXHIBIT N

September 30, 1987

IR MICROSCOPY OF EXPLANTED PROLENE\*  
RECEIVED FROM PROF. R. GUIDOIN

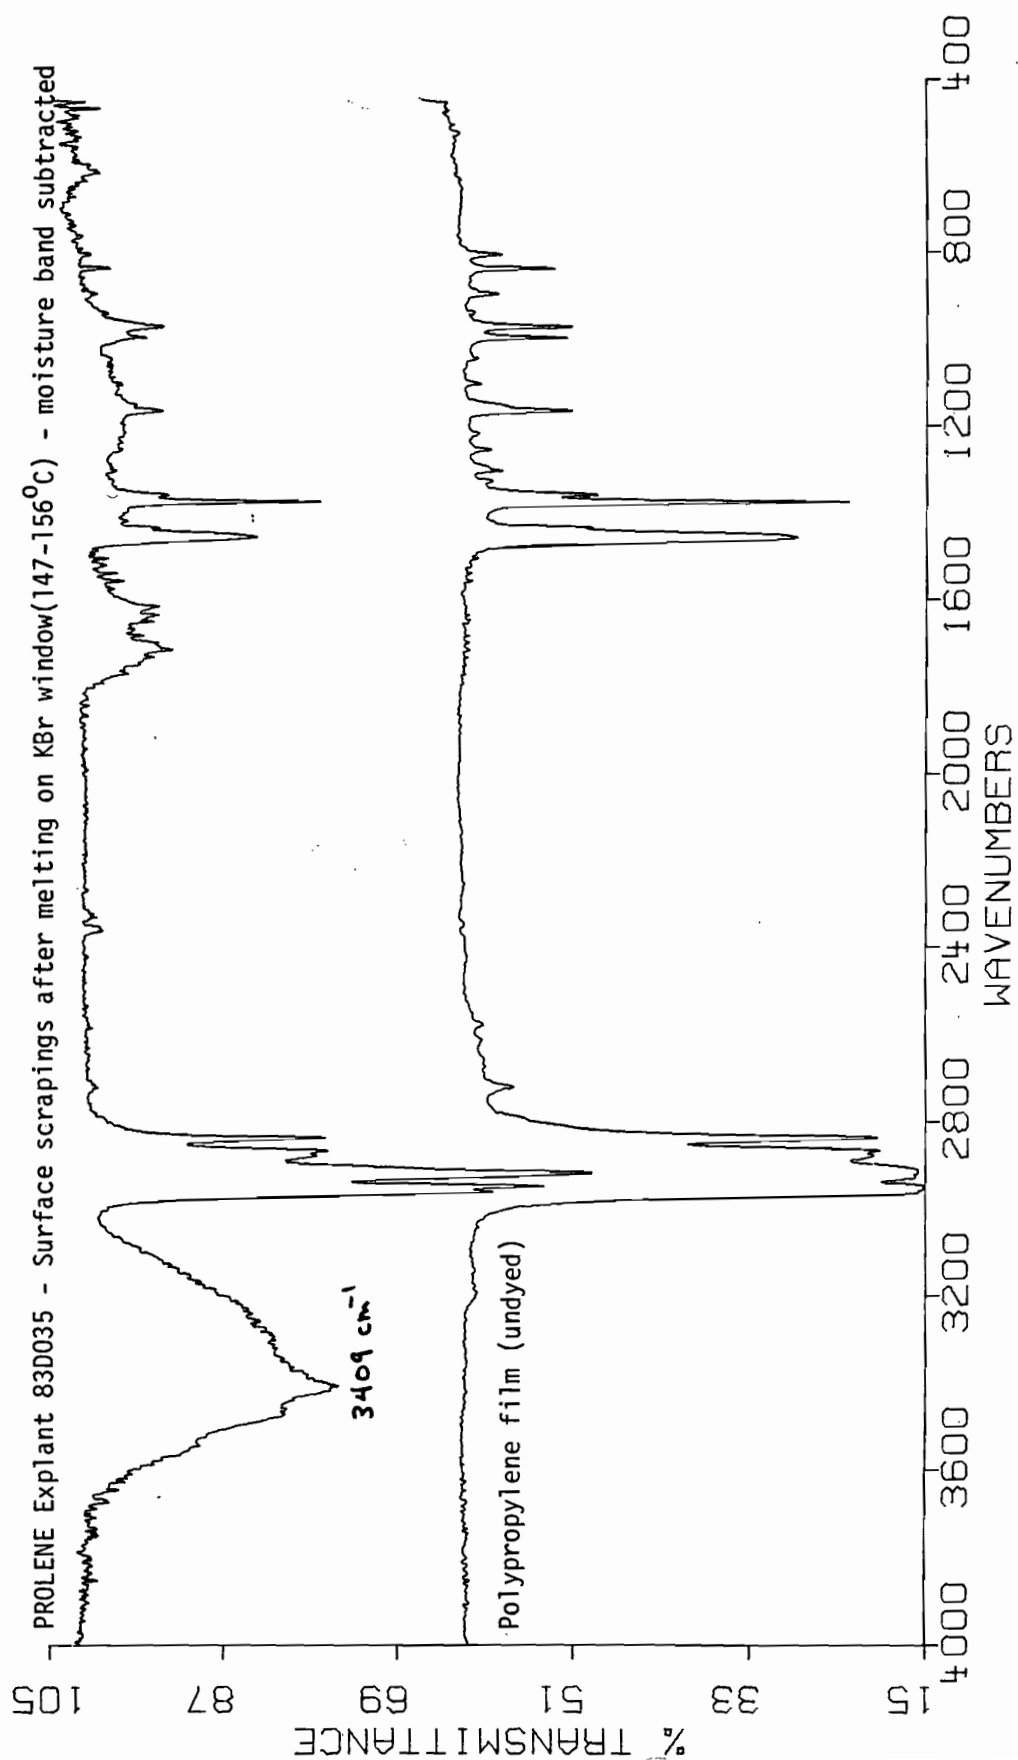
The surface scrapings of 83D035 were melted at 147°-156°C on the Mettler hot stage. This is the melting range previously observed for oxidatively degraded polypropylene. IR microscopy of the melted film produced (Figures 10 & 11) yielded good spectra.

The observation of chemical species in the surface scrapings spectra of 83D035, yet not seen in the "bulk" spectra (surface + interior) of the suture explants, suggests that the regions affected by cracking or degradation are very small relative to the entire suture. The surface scraping spectra are very different from the "bulk" spectra, and both types of spectra show no evidence of the presence of protein.

The surface scrapings spectra of 83D035 clearly indicate polypropylene, but also three or four other broadened bands. Table I explains the possible functionalities determined from a library search of the IR bands not normally seen in polypropylene.
